The above picture reveals four variables when installing the Uni-Push end joint system

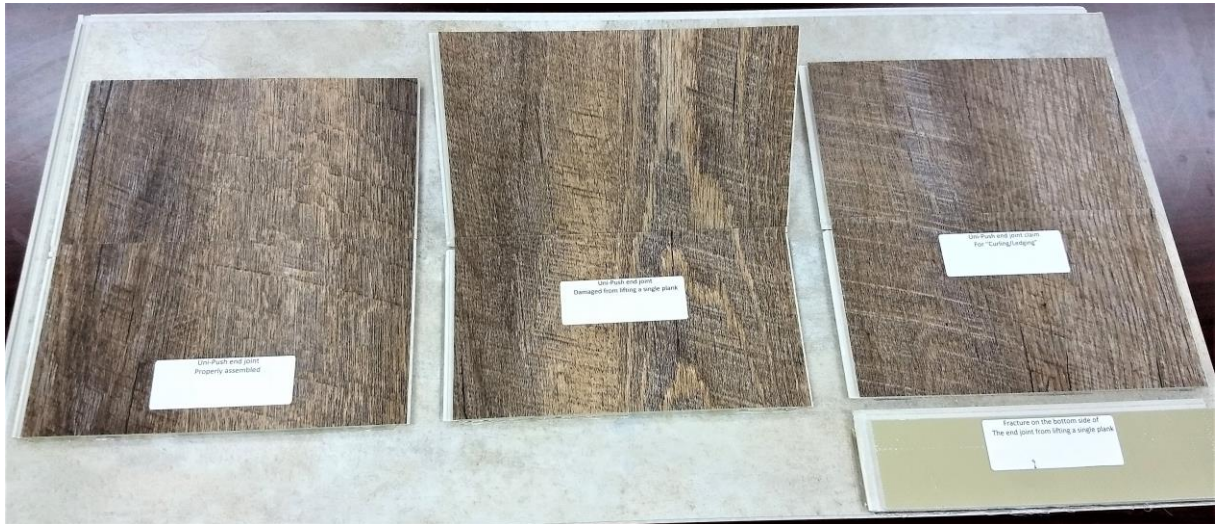
1. A properly assembled joint
2. What happens when a single plank is raised to remove a plank
3. The end joint after the plank has been lowered
4. The bottom side of the plank revealing the fracture of the joint that is never seen by the installer.

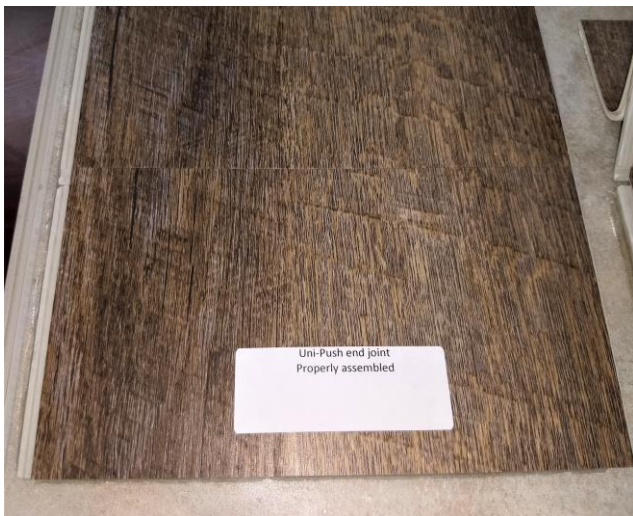
This is a properly engaged Uni-Push end joint

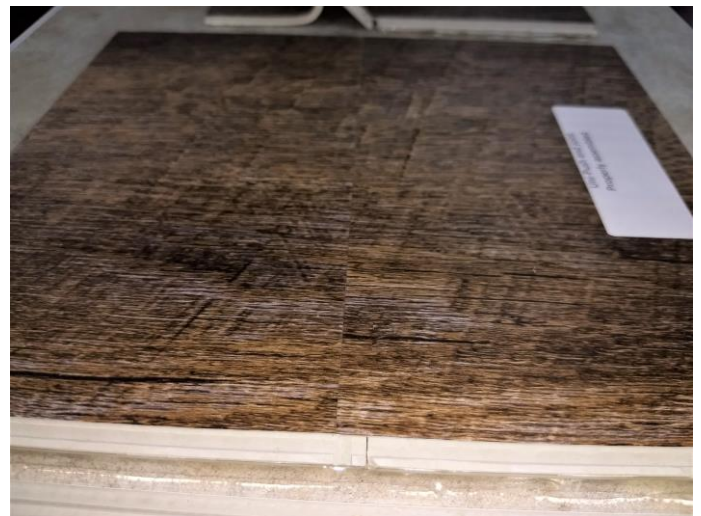
Side view of a properly engaged Uni-Push end joint

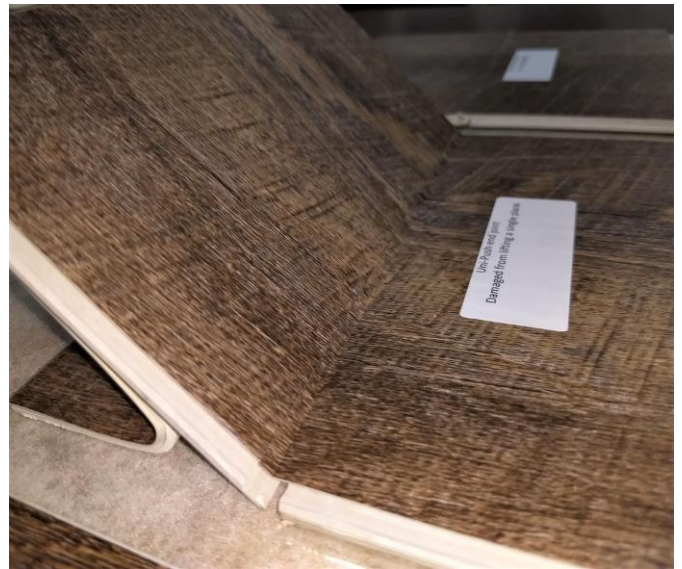
When a plank is lifted the upper edge of the profile will bend and remain attached

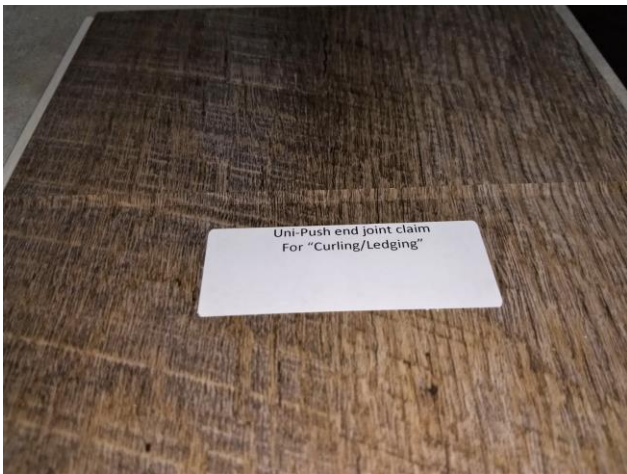
End view of plank with raised edge. This is an installation condition.

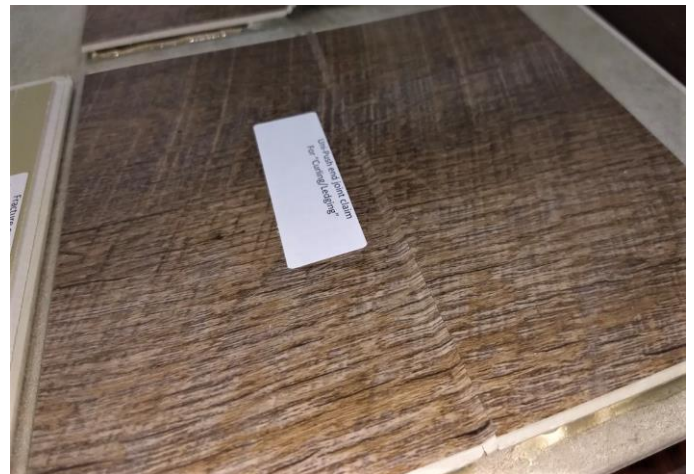
Side view of plank with raised edge. This is an installation condition.

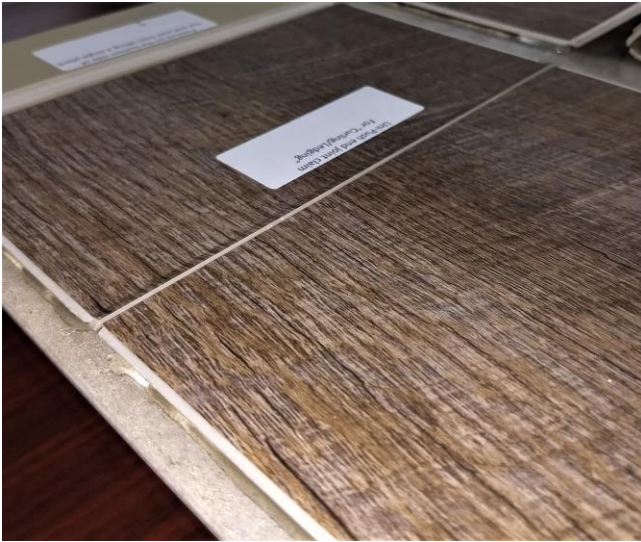
Looking into the raised end of the damaged Uni-Push end joint.

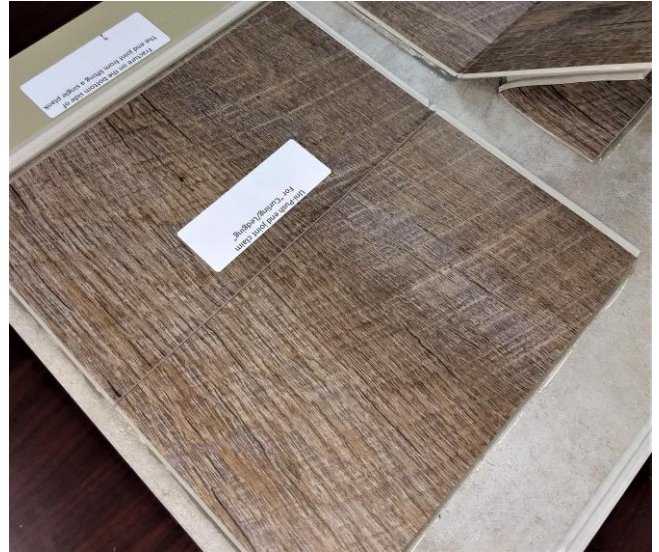
Looking down towards the raised end of the damaged Uni-Push end joint.

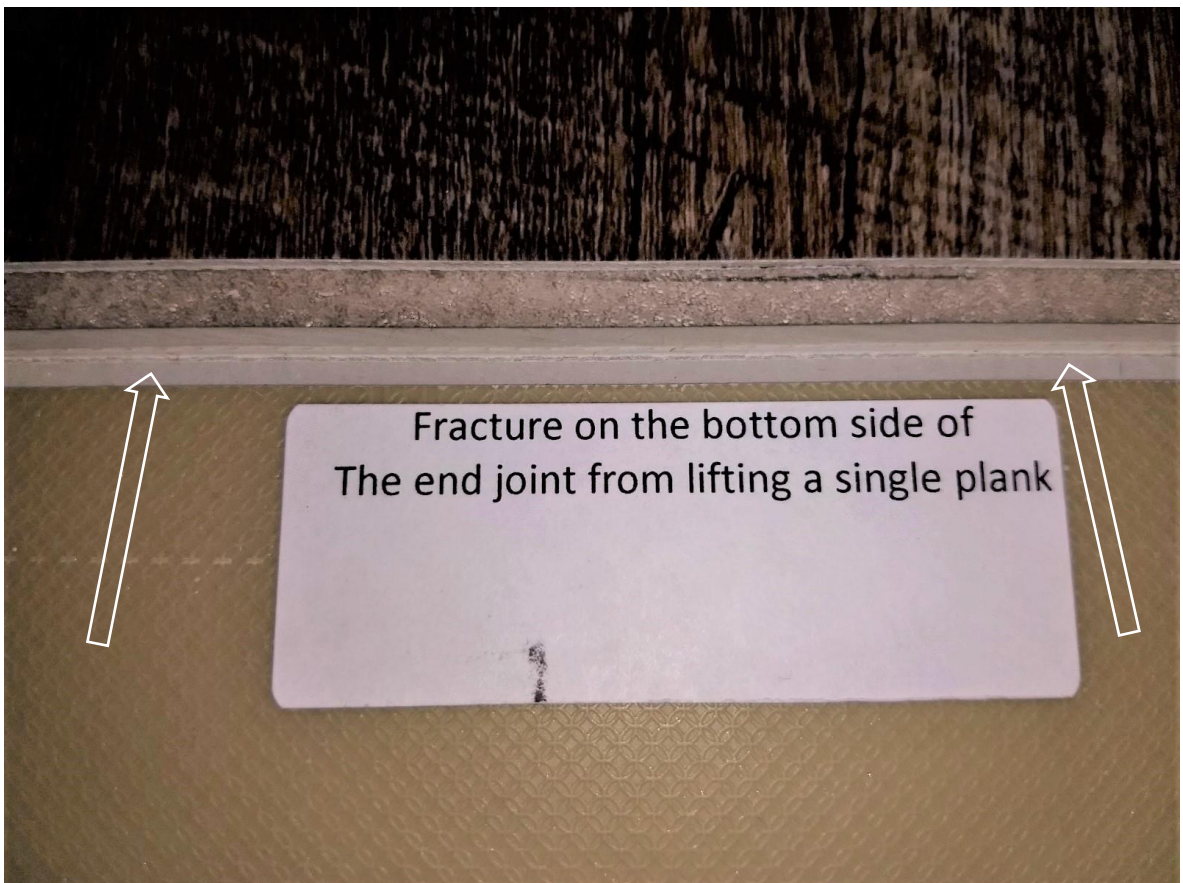
Fracture on the bottom side of
The end joint from lifting a single plank

The bottom side of the end joint will fracture. This fracture will never be noticed by the installer when being installed. The upper portion will show a raised edge (as seen in other pictures). If the installer forced the edge back down the integrity of the joint will never remain stable and will eventually lift. This is an installation related condition but commonly mistaken for lifting ends.
